PROJECT SUMMARY REPORT FOR

RED CROSS- PADF AYITI INITIATIVE ON RECONSTRUCTION (REPAIR)

DECEMBER 2012

Report prepared by:
Miyamoto International, Inc.
www.miyamotointernational.com

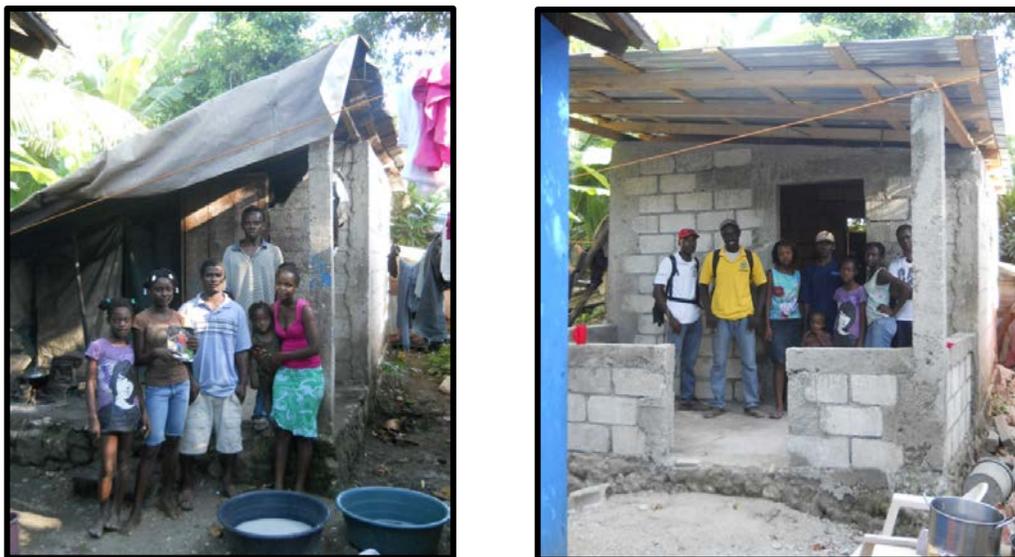
Fig. 01 – Home before (Left) and after the program (Right)

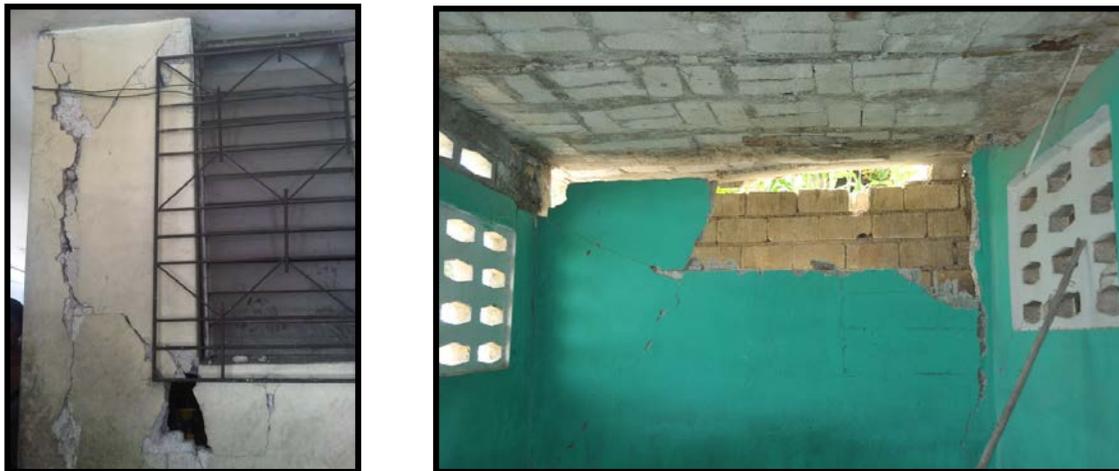
Many of the structures in Haiti are of a building type that is vulnerable to seismic damage. These buildings use a variation of confined masonry construction comprising weak hollow concrete blocks (HCBs) with lightly reinforced and non-ductile beams and columns. See Fig. 03 for typical earthquake damage to houses.

Fig. 03 – Shear cracking in wall pier (Left), Out of plane failure of CMU wall (Right)

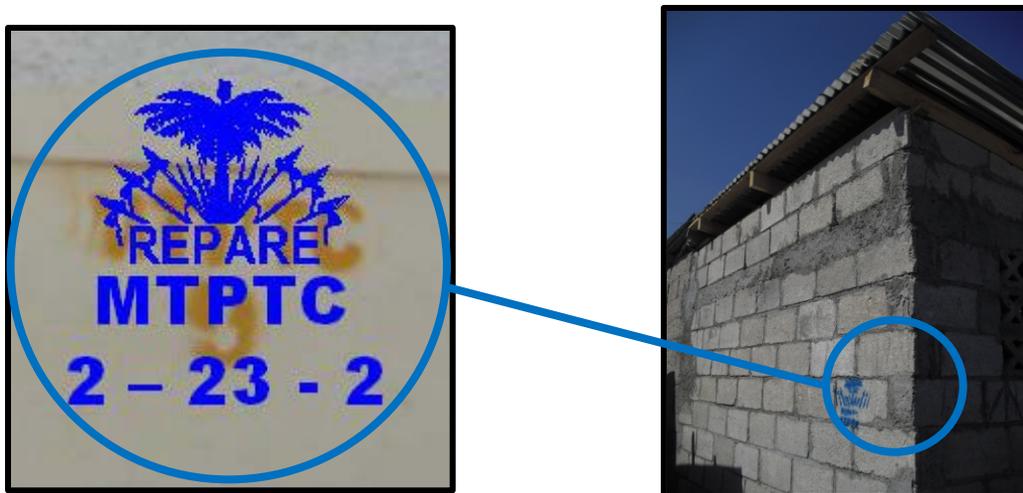
Fig. 12 – Example MTPTC Stamp of Repaired House

The QA/MTPTC engineer would first verify the house was completed; next the CM was responsible for signing off on the completed work and then informed Miyamoto engineer to come and certify that the house was in fact finished to the standards set by the Red Cross, PADF, and Miyamoto International. Upon the completion of house repairs, an MTPTC Engineer would sign-off on the Construction Agreement and the house would be eligible to receive a standardized MTPTC blue seal as shown in Fig. 12.

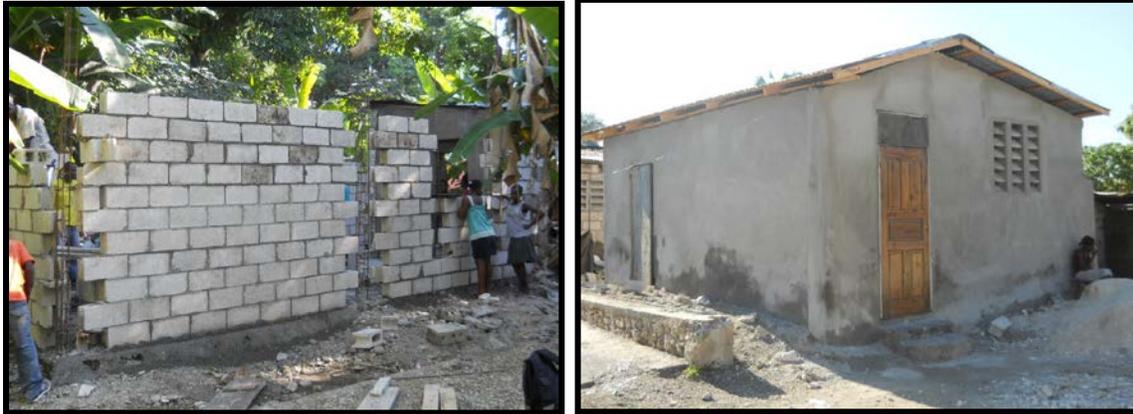
Fig. 18 – Typical Repairs
