PROJECT SUMMARY REPORT FOR

RED CROSS- PADF AYITI INITIATIVE ON RECONSTRUCTION (REPAIR)

DECEMBER 2012

Report prepared by:
Miyamoto International, Inc.
www.miyamotointernational.com

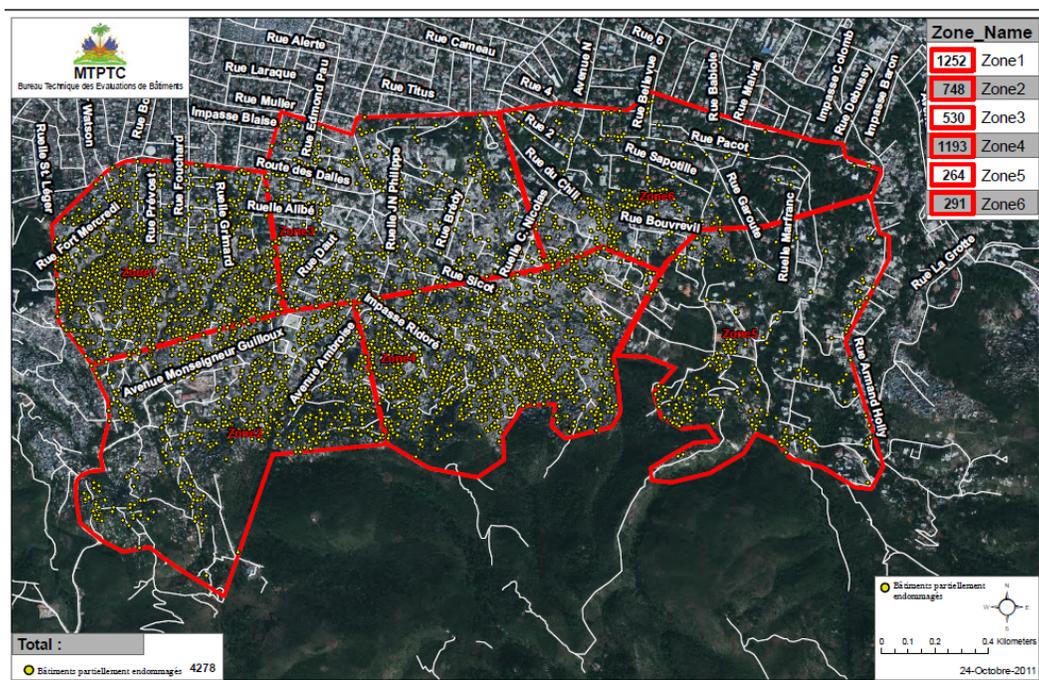
Fig. 11 – Map Identifying Yellow Houses - CFF

The actual repair process begins by choosing a large geographical area where the repairs will take place. In this case, the program focused on the neighborhood of Carrefour Feuille. Miyamoto and PADF staff mapped the area using streets and topical features to divide the area into small workable zones (Fig. 11). The CMs were then each assigned to zones in which they organized and controlled the repair process. To begin, the QA engineers were teamed with a CM and sent to their zones to identify and assess the damage of the houses that were to be repaired.

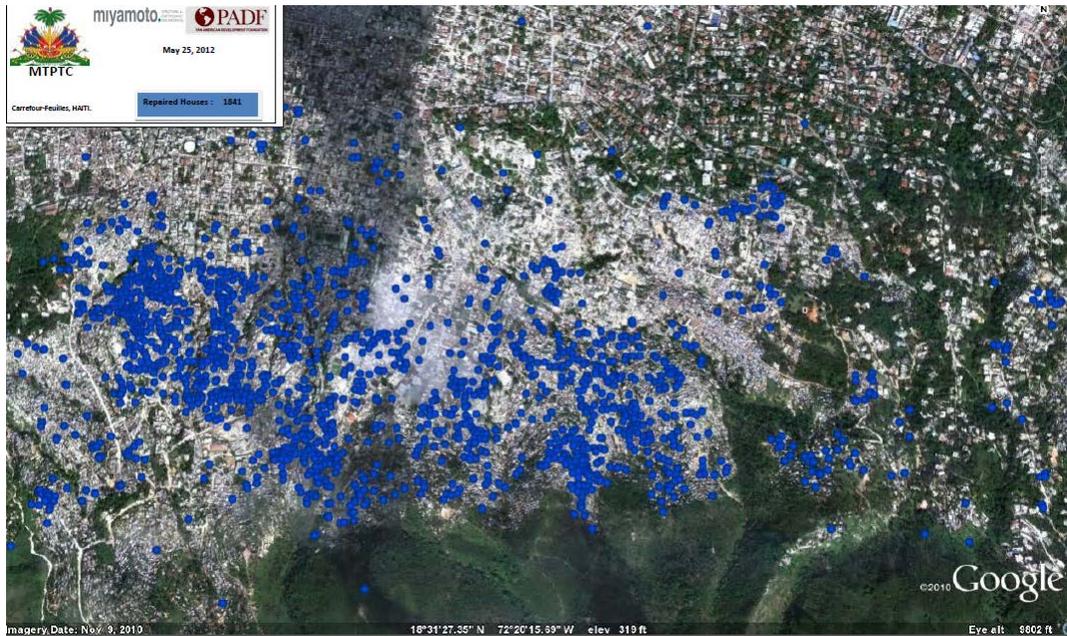
Fig. 16 – Map of Repaired Houses - Carrefour

those who took part in it. The map in Figure 16 shows the repaired houses in Carrefour Feuille, identified in blue dots.

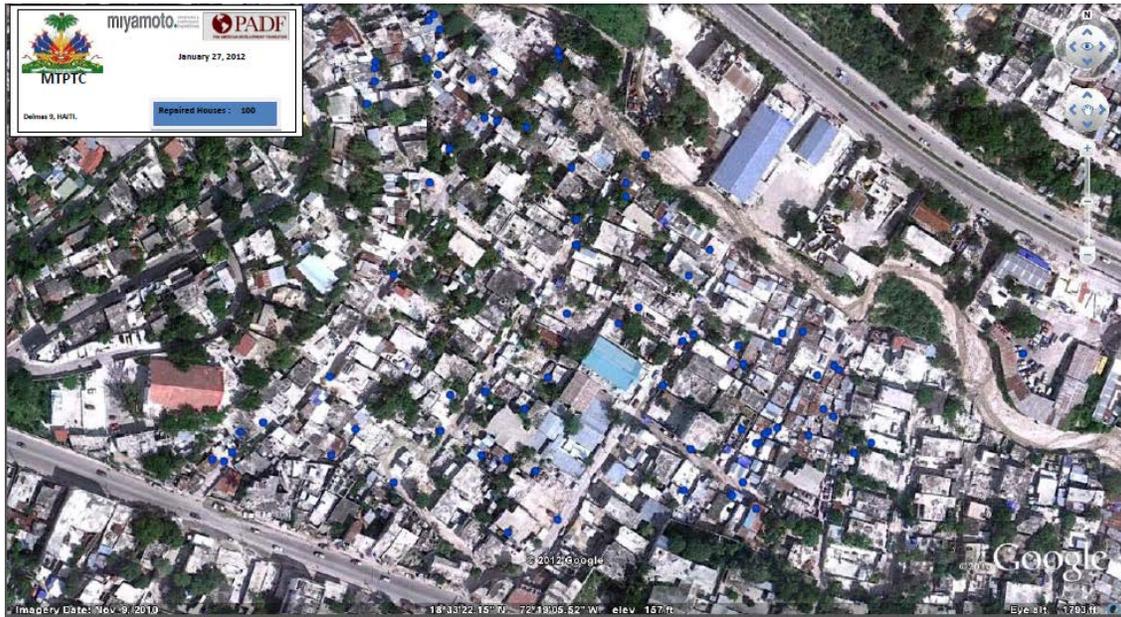
Fig. A1 - Completed Houses Delmas 9

The project started with the repair in Delmas 9 in November 2011 with the French Red Cross (FRC) as beneficiaries. A total of 102 houses were certified (see Fig A1). FRC generated an observation report to PADF based on a scope of work that seemed different from the agreement Miyamoto had with PADF. The level of repair FRC requested was more involved than what was anticipated. The scope of work started to evolve in Delmas 9, and by the time the project reached Carrefour Feuille, more repair works were done compared to the initial contract.
